**Remediation Weekly Activity Summary Report  
Ameren Columbia MGP - Remedial Action**

**Project Week No.:** Twenty  
**Period:** 5/26 - 5/30/2014  
**Completed By:** Dave Pluhar

**PSC Project Number:** 624-1302-0002

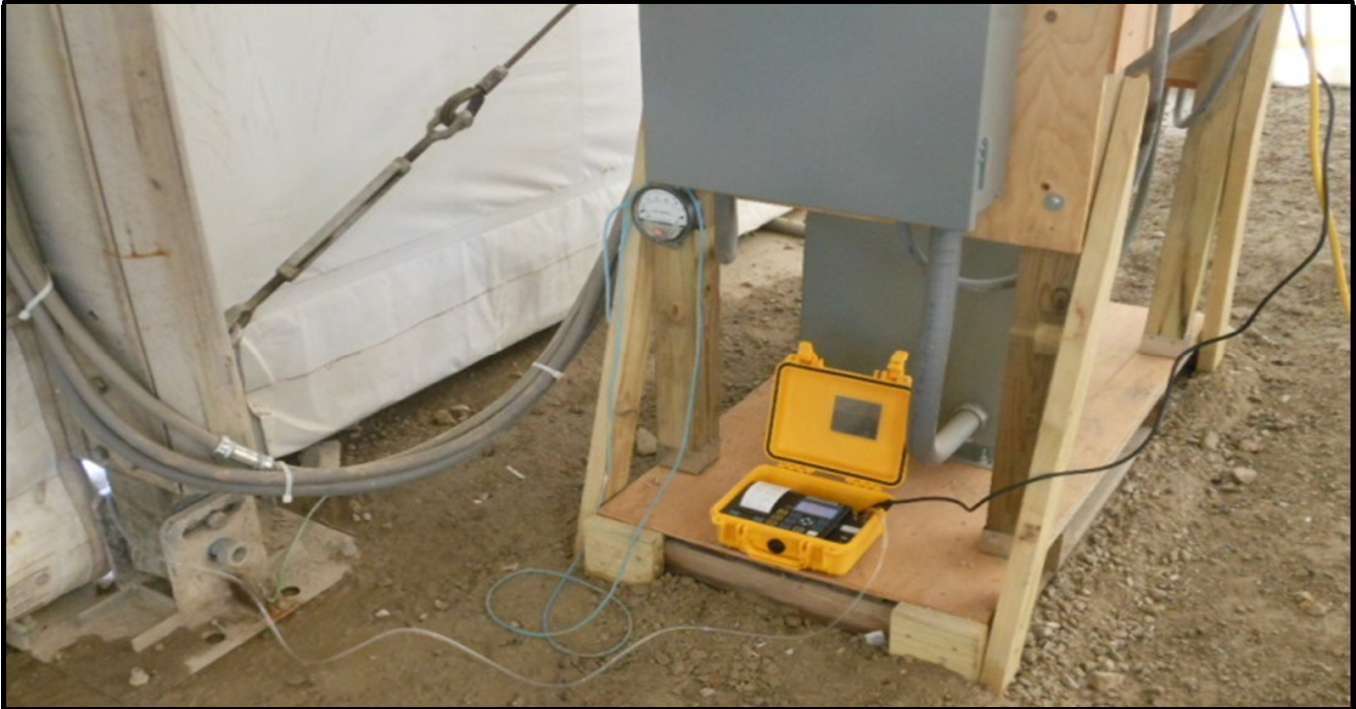
The differential pressure between the temporary structure interior & outside ambient conditions created by the air handler draft is being monitored and recorded by an automated differential pressure monitor/data logger.

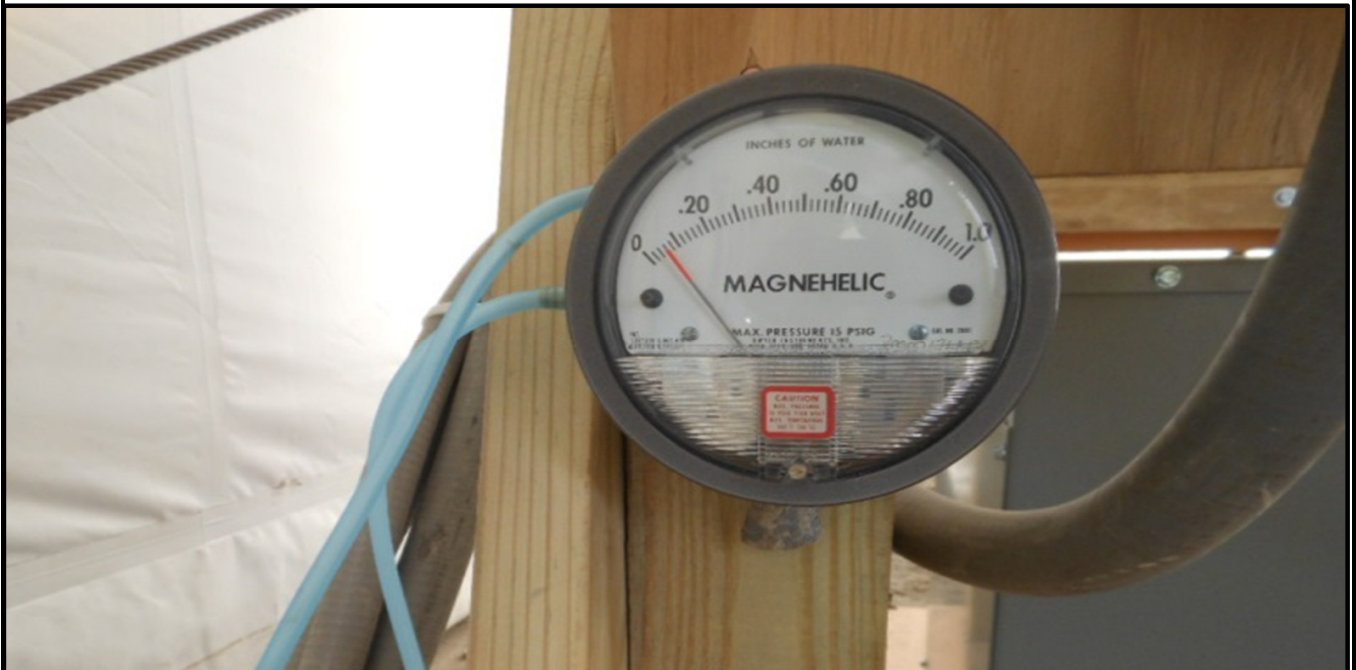
A differential pressure magnehelic gauge monitoring the difference between the structure interior and outside ambient pressure is being used as a QA check.

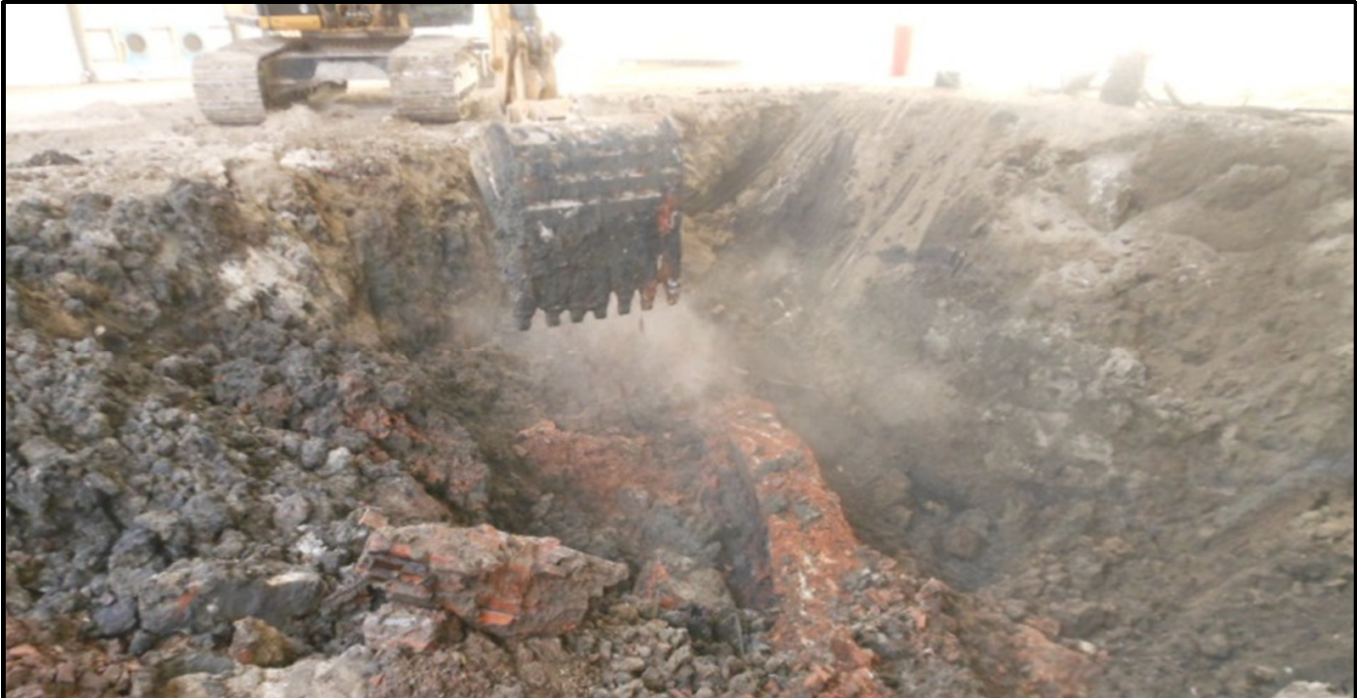
The excavation work during Week 20 focused on the removal of the gas holder tank and the tank contents

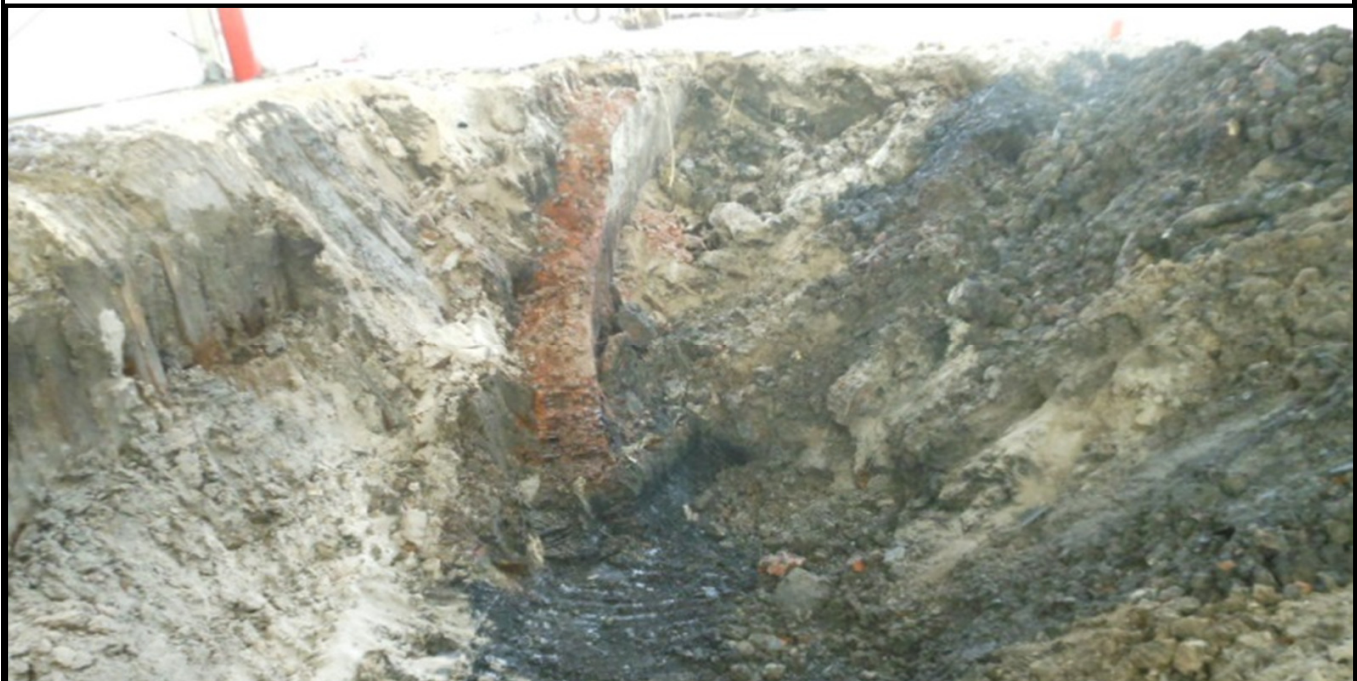
The removal of the gas holder tank proceeded in the southwest corner of the Phase III excavation area east of the sheet pile wall. The sheet pile wall is visible in the left vertical area of the excavation.

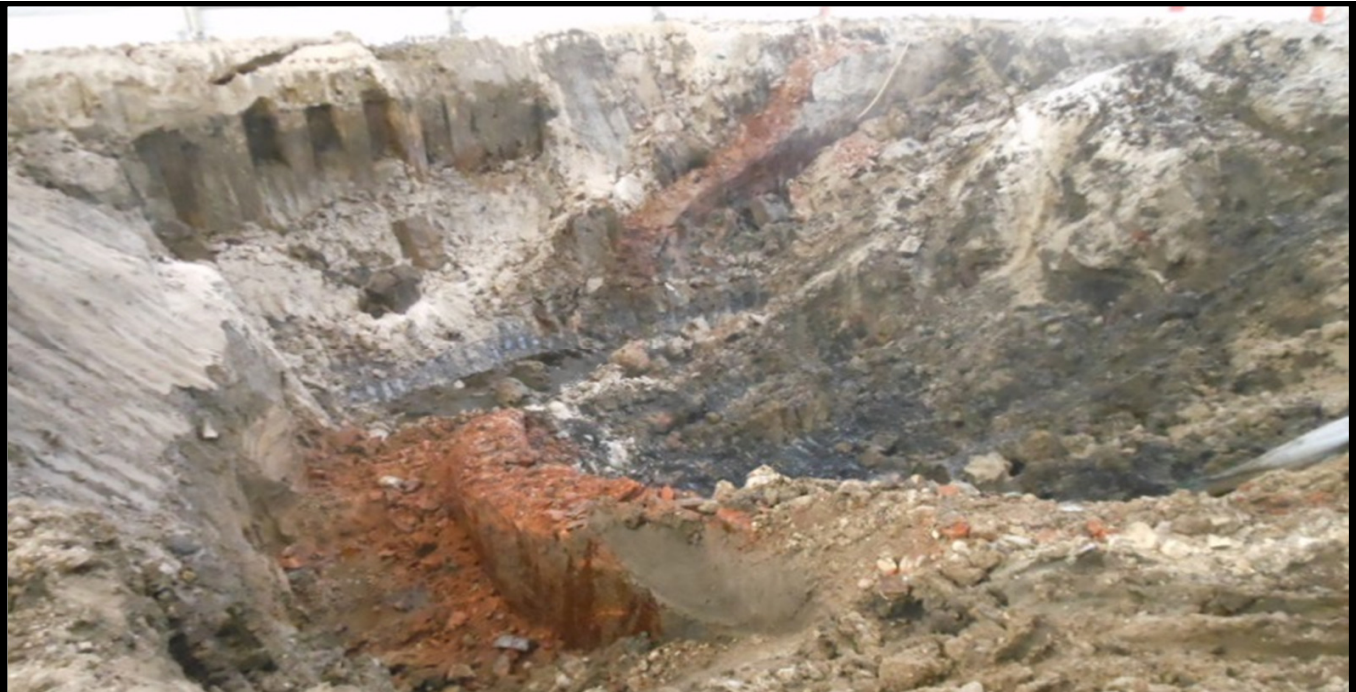
The gas holder tank wall is being removed down to the tank floor which rests on the coal formation present beneath the Site.

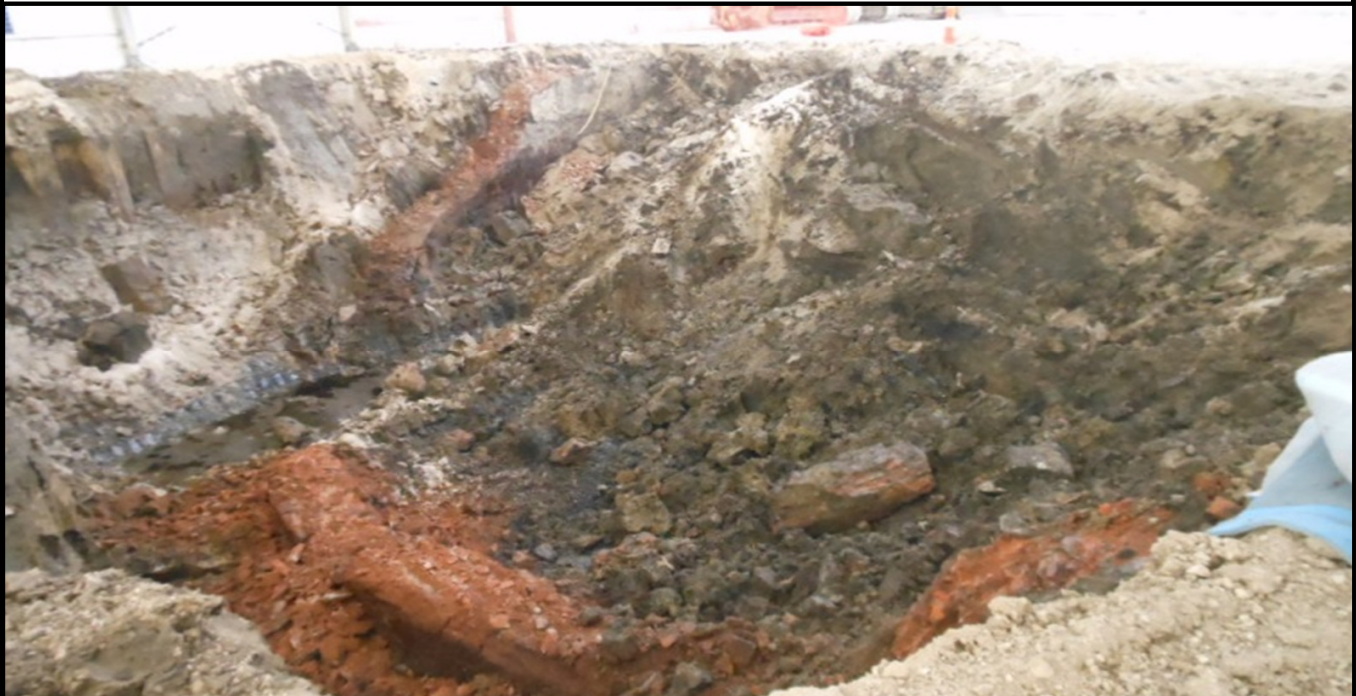
The excavation progress mid-week.

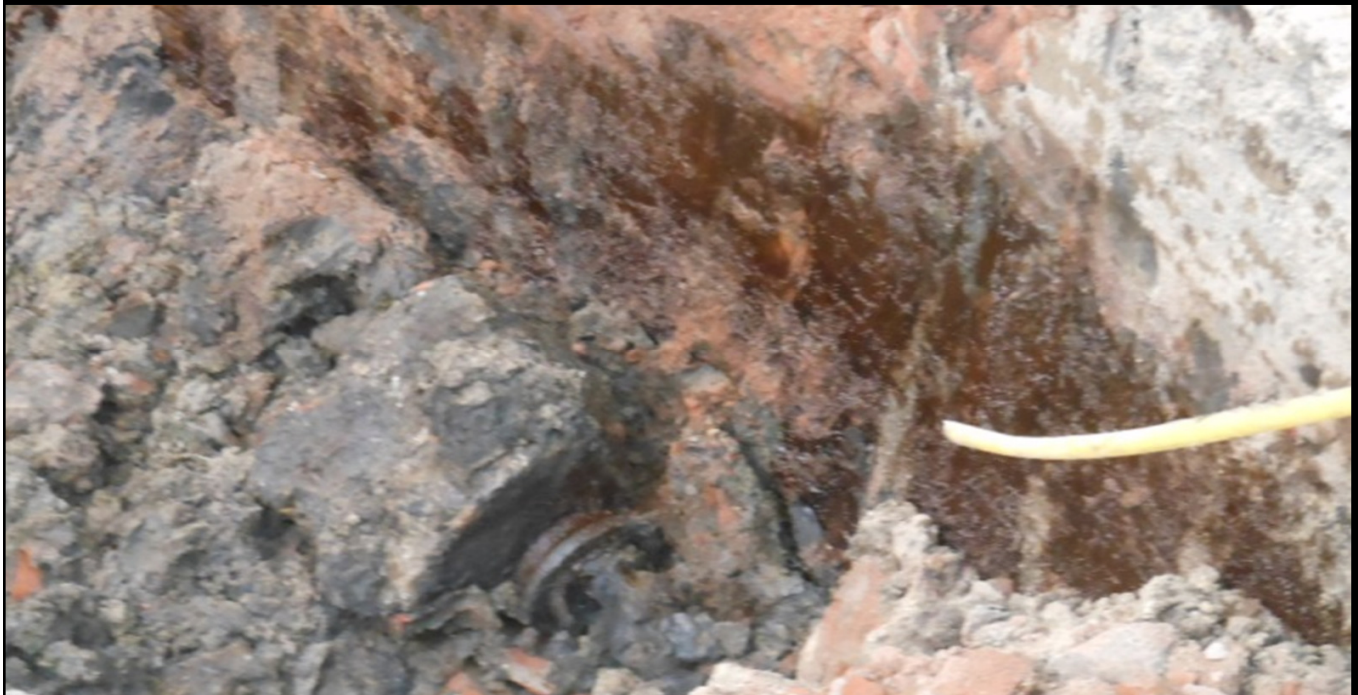
The impacts within the gas holder tank are slight to moderate, and process piping debris has been present in the tank fill material.

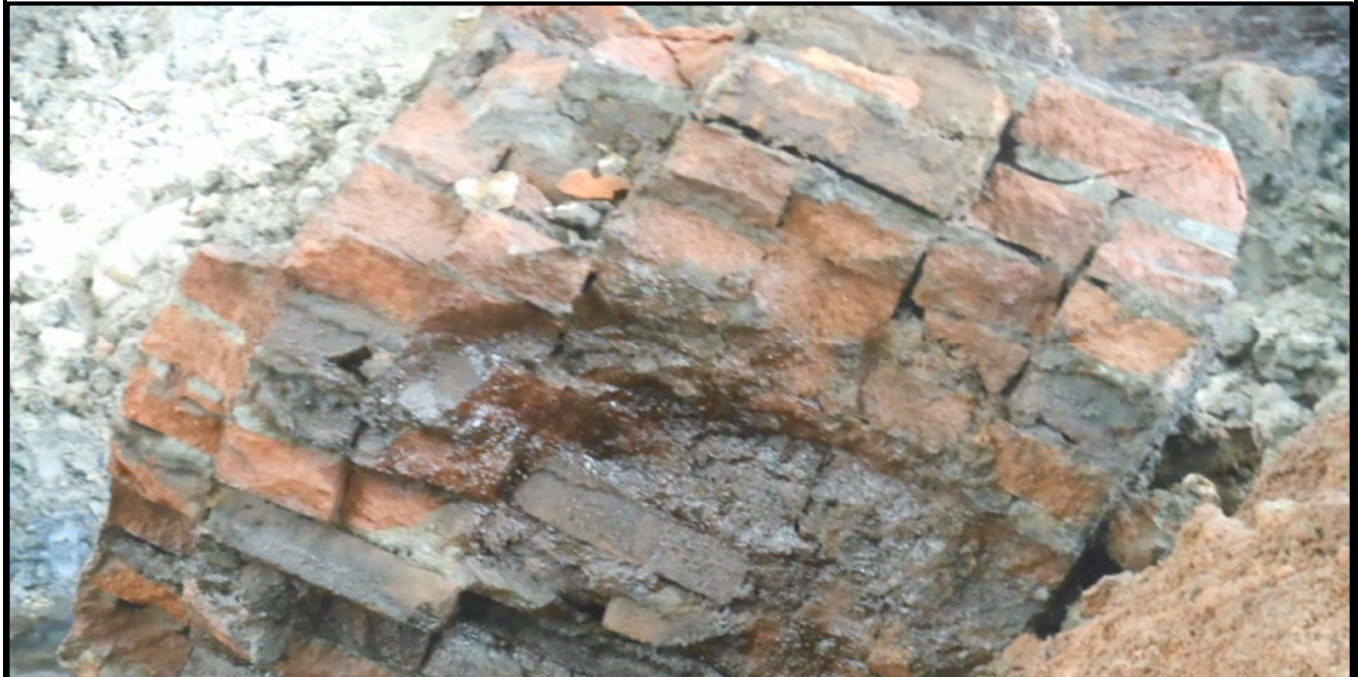
A portion of the gas holder tank wall illustrating the thickness of the tank wall - between 1.5 and 2.0 feet thick.
